Aviation Maintenance Alerts

AC No. 43-16A

**ALERT NO. 262
MAY 2000**

**Improve Reliability-
Interchange Service
Experience**

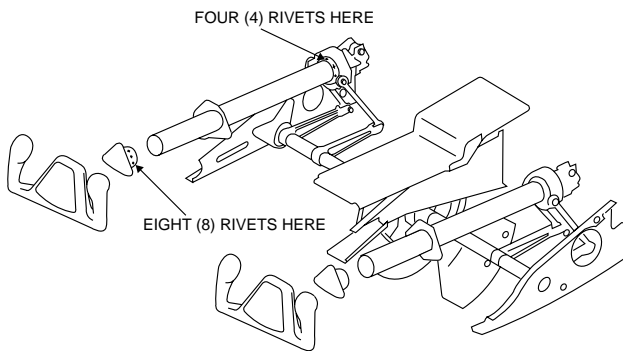
Investigating further, the technician found the rivets, used to secure the forward collar to the control yoke tube, were severely worn and working. (Refer to the following illustration.) As depicted, there are four rivets (P/N MS2047AD5) used for the forward collar and eight rivets for the aft collar. The technician questioned the logic of using eight rivets on the aft control yoke tube and only four rivets on the forward collar. He replaced the defective rivets with rivets that are one size larger (P/N MS20470AD6) to obtain a

proper fit. Failure of these fasteners could completely disable the aileron and elevator flight control systems and create a very serious hazard to flight safety.

The submitter contacted the manufacturer who advised him the four rivets on the forward collar were sufficient to secure the forward collar. This report, along with supporting information, was forwarded to the responsible FAA Aircraft Certification Office for appropriate action.

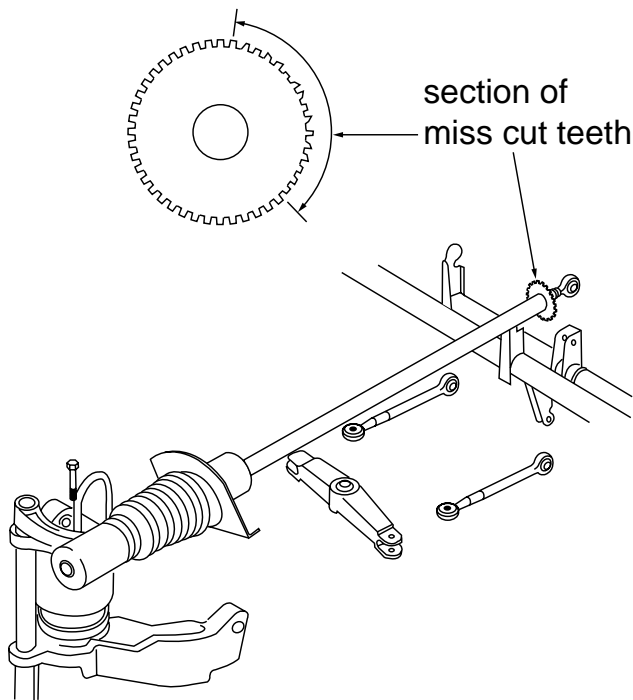
The technician reinstalled the chain and conducted another test while observing the chain travel on the sprocket gear. The chain rode normally for approximately two-thirds of a revolution then began riding up on the top of the sprocket teeth and disengaged from the sprocket. After removing the sprocket and conducting a close inspection, the technician found some of the sprocket teeth were not symmetrical and were cut differently from the others. (Refer to the following illustration.)

If this situation happened once, it may happen again. There could be other nonstandard parts in the distribution system. A thorough receiving inspection on all parts is the best remedy.

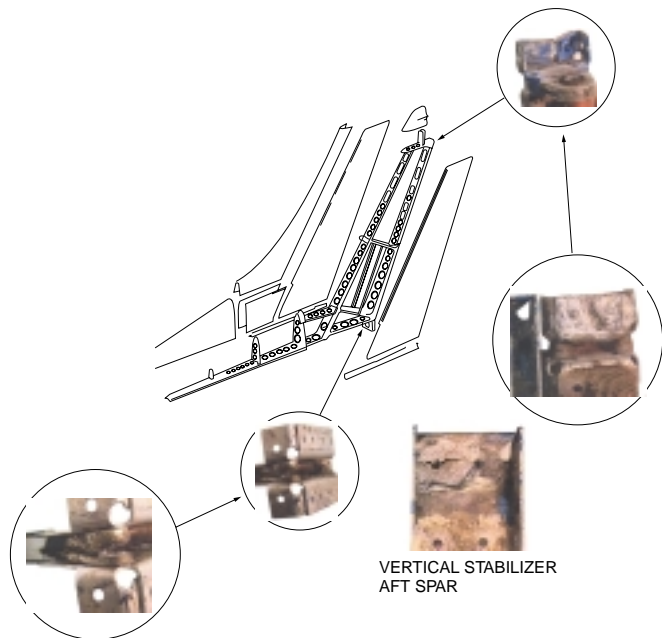
During an annual inspection, the technician discovered severe corrosion on the upper rudder attachments (P/N 1231023-3) and the lower rudder attachments (P/N 1231023-1). (Refer to the following illustration.) The aft vertical stabilizer spar was also severely damaged at the points where the rudder hinge brackets are attached.

With this amount of damage, complete loss of rudder could occur at any time.

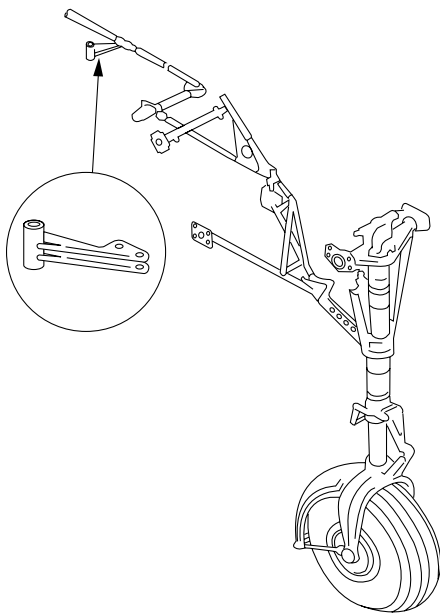
A maintenance technician investigated and discovered a broken nose gear idler bellcrank (P/N 0842102-2). (Refer to the following illustration.) Failure of the idler bellcrank effectively disconnected the nose gear linkage and did not allow the gear to extend normally.

The submitter recommended that technicians remove the bellcrank every 500 hours. After the bellcrank is removed, use an appropriate nondestructive-testing method to determine serviceability.

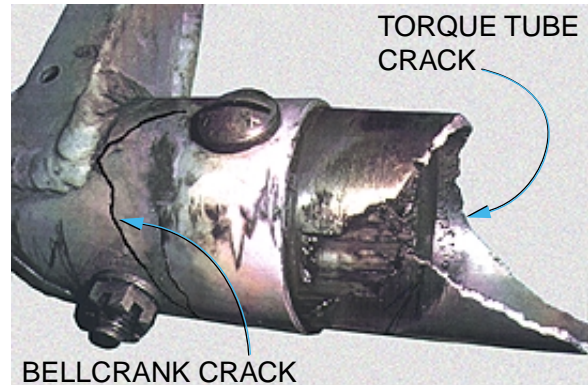
An investigation by maintenance personnel disclosed the wing flap torque tube (P/N 17634-00) was cracked around approximately 80 percent of its diameter. (Refer to the following illustration.) The crack was located adjacent to the left bellcrank, and the bellcrank was severely cracked. The submitter speculated this defect may have been caused by age (many years of operation) and extending the wing flaps at excessive airspeeds. He speculated the crack began as a small defect, and over time, migrated to the brink of complete failure. Maintenance personnel should be alert for this type defect, especially on older, high-time aircraft.

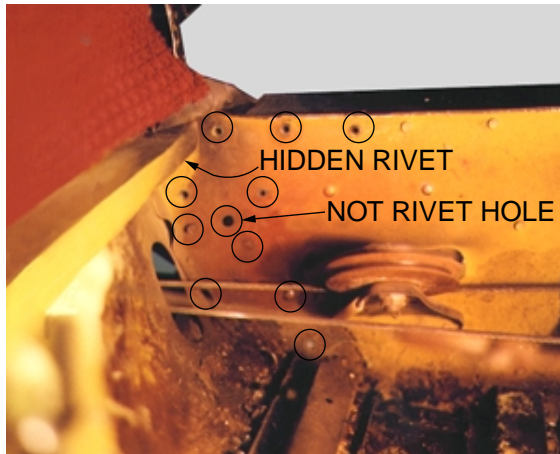
Twelve rivets were broken and missing from the right rear wing attachment fitting (P/N 23663-00) at fuselage station 136. (Refer to the following illustration.) Further inspection revealed the technician could move the right wing trailing edge up and down using hand pressure. He checked the other three wing attachment fittings and found them in good condition.

The submitter speculated this defect was caused by hard landings. The maintenance records indicated this aircraft was involved in two previous accidents, and it is possible damage went undetected during repairs. The FAA Service Difficulty Reporting (SDR) program data base contains two additional entries of similar failures. This aircraft was in imminent danger of in-flight wing separation.

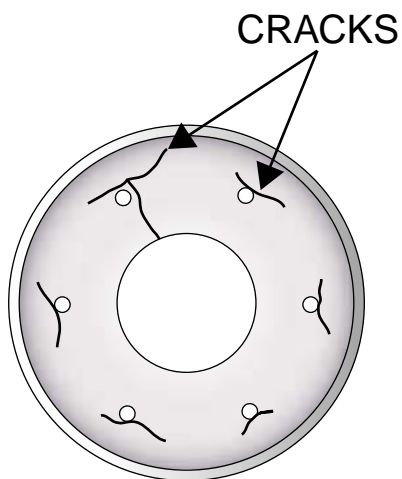
The cracks were located at or adjacent to each of the attachment bolt holes. (Refer to the following illustration.) There were no dynamic balance weights attached to the bulkhead.

The submitter suggested the manufacturer redesign the spinner bulkhead using heavier metal to prevent this type of defect.

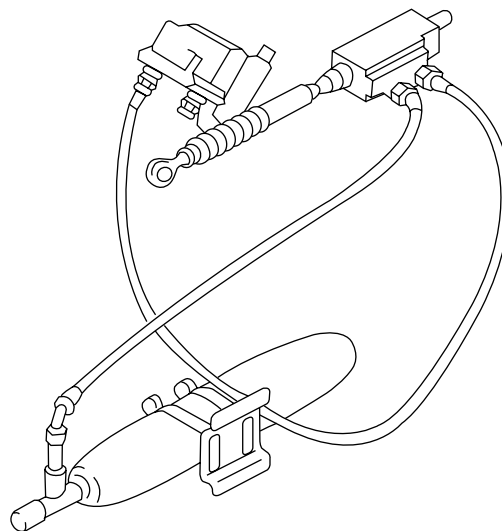
The actuator (P/N 551-968) was leaking where the rod enters the housing. (Refer to the following illustration.) The technician installed a new actuator, bearing the same part number. The new actuator leaked from the end cap during an operational test. He

installed two other actuators, and they both leaked at the end cap. After installing the fourth new actuator, an operational test was satisfactory.

The submitter speculated the defective actuators were the result of a manufacturing problem.
